**CHROMIC ACID SOIL REMEDIATION
AT DOUGLAS AIRCRAFT COMPANY
C6 FACILITY IN TORRANCE, CALIFORNIA
13 May 1988**

Douglas Aircraft Company
3855 Lakewood Boulevard
Long Beach, California 90846

Woodward-Clyde Consultants
203 North Golden Circle Drive
Santa Ana, CA 92705

Project No. 8741863D

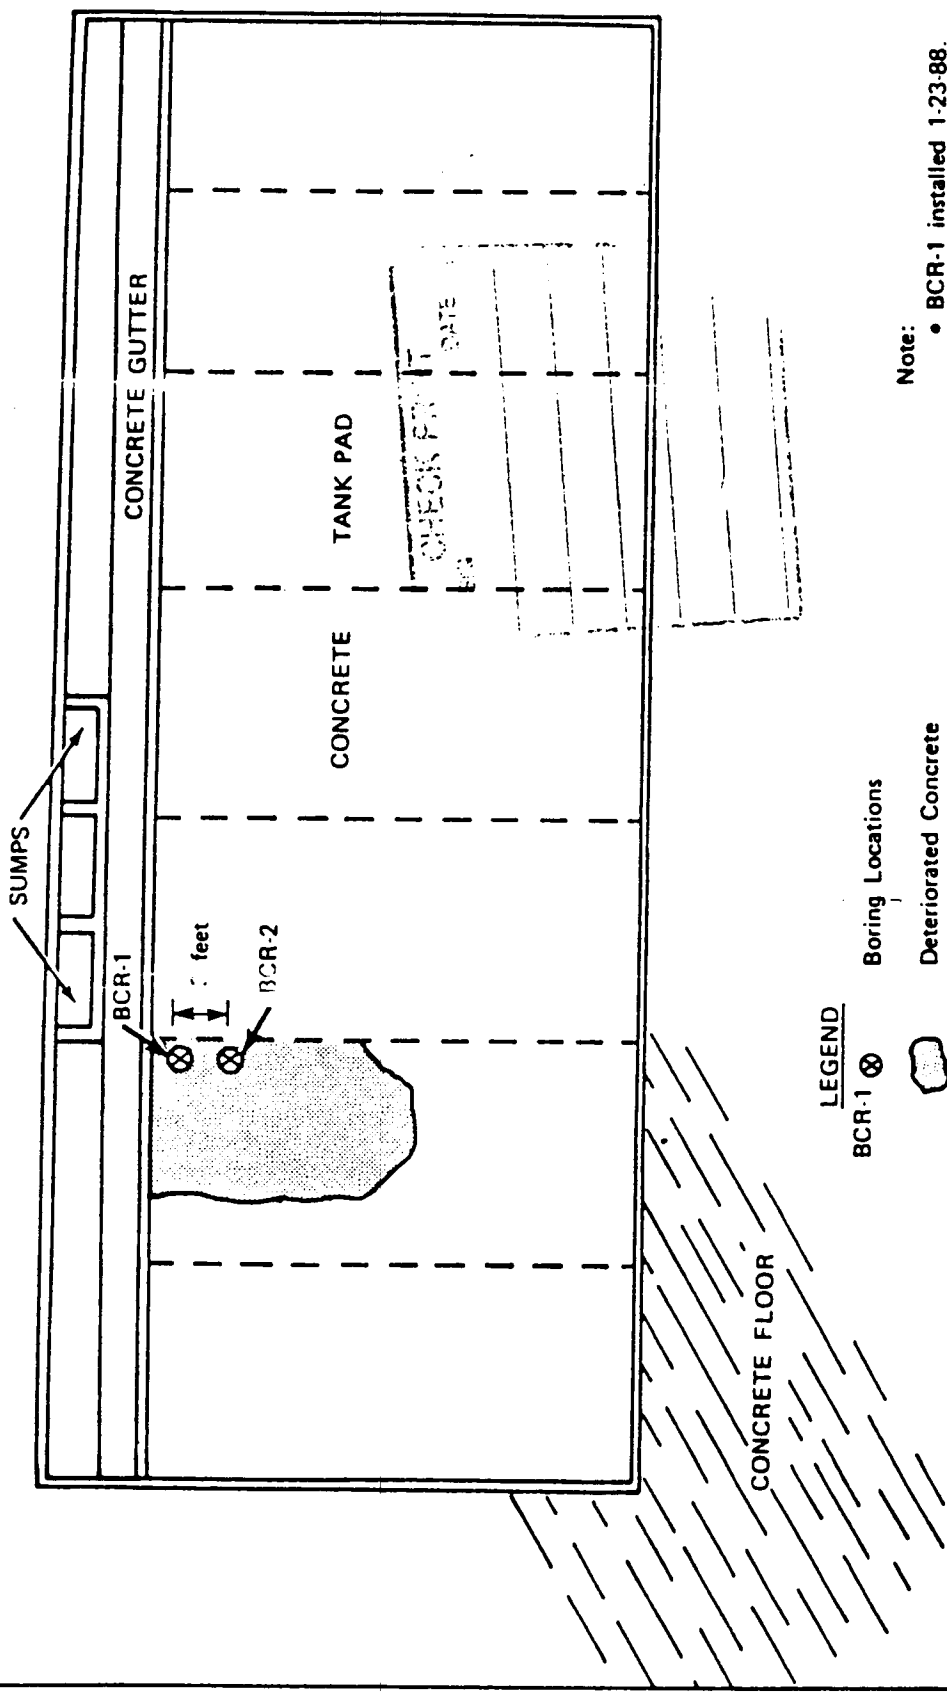
Fig. 2

The chromic acid tank and the two adjacent rinse tanks were removed for replacement on 17 January 1988. Removal of these tanks exposed an area (approximately 6 x 10 feet) of deteriorated concrete under the chromic acid tank. The cement matrix of the 6-inch thick concrete pad had deteriorated to a friable powder varying in depth from approximately 1/2 to 6 inches into the concrete (see Figure 2).

TANK PAD LOCATION MAP

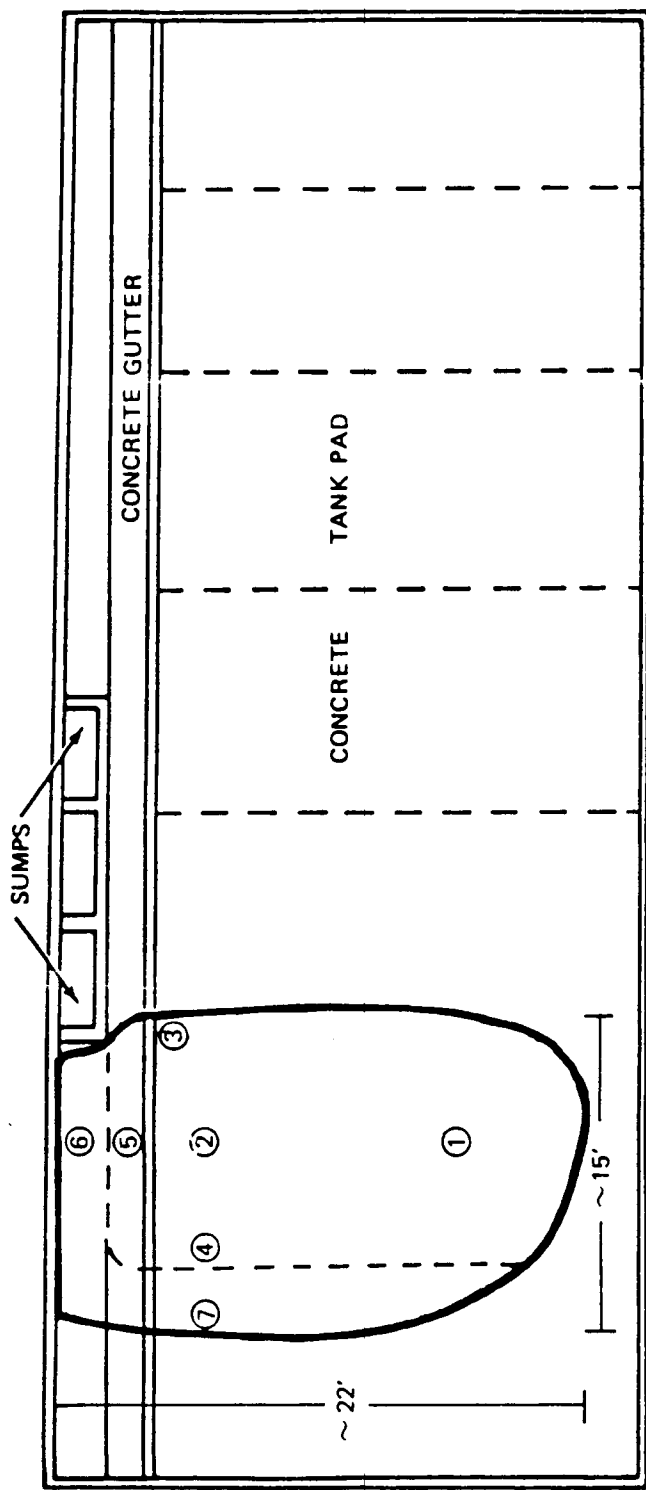
Fig. 3

BORING LOCATION MAP

Additional soil was removed from the north and west sidewalls of the excavation on 28 and 29 April 1988, because analytical results indicated the presence of chromium in these areas. An additional 3 to 4 feet of soil and concrete were removed from the north and west end of the excavation, see Figure 3. On 29 April 1988, soil samples Chrome -6 and -7 were collected from the north and west sidewalls, respectively, for laboratory analyses. The analytical results obtained from the soil sample are discussed in Section 3.0.

On 16 April 1988, soil samples Chrome-1, -2, -3, -4, and -5 were collected from the bottom and sidewalls of the excavation, see Figure 3. The analytical results obtained from samples Chrome-4 and -5 indicated chromium concentrations of 78 and 1,300 mg/kg present in the west and north sidewalls, respectively. Soil samples Chrome-1, -2, and -3 had chromium concentrations below 50 mg/kg, indicating that the vertical extent of chromium had been delineated. Soil samples Chrome-6 and -7 were collected on 29 April 1988 following additional soil removal from the north and west sidewalls. The analytical results from the north sidewall (Chrome-6) indicated 176 mg/kg of chromium and the west sidewall (Chrome-7) had 32 mg/kg of chromium in the soil.

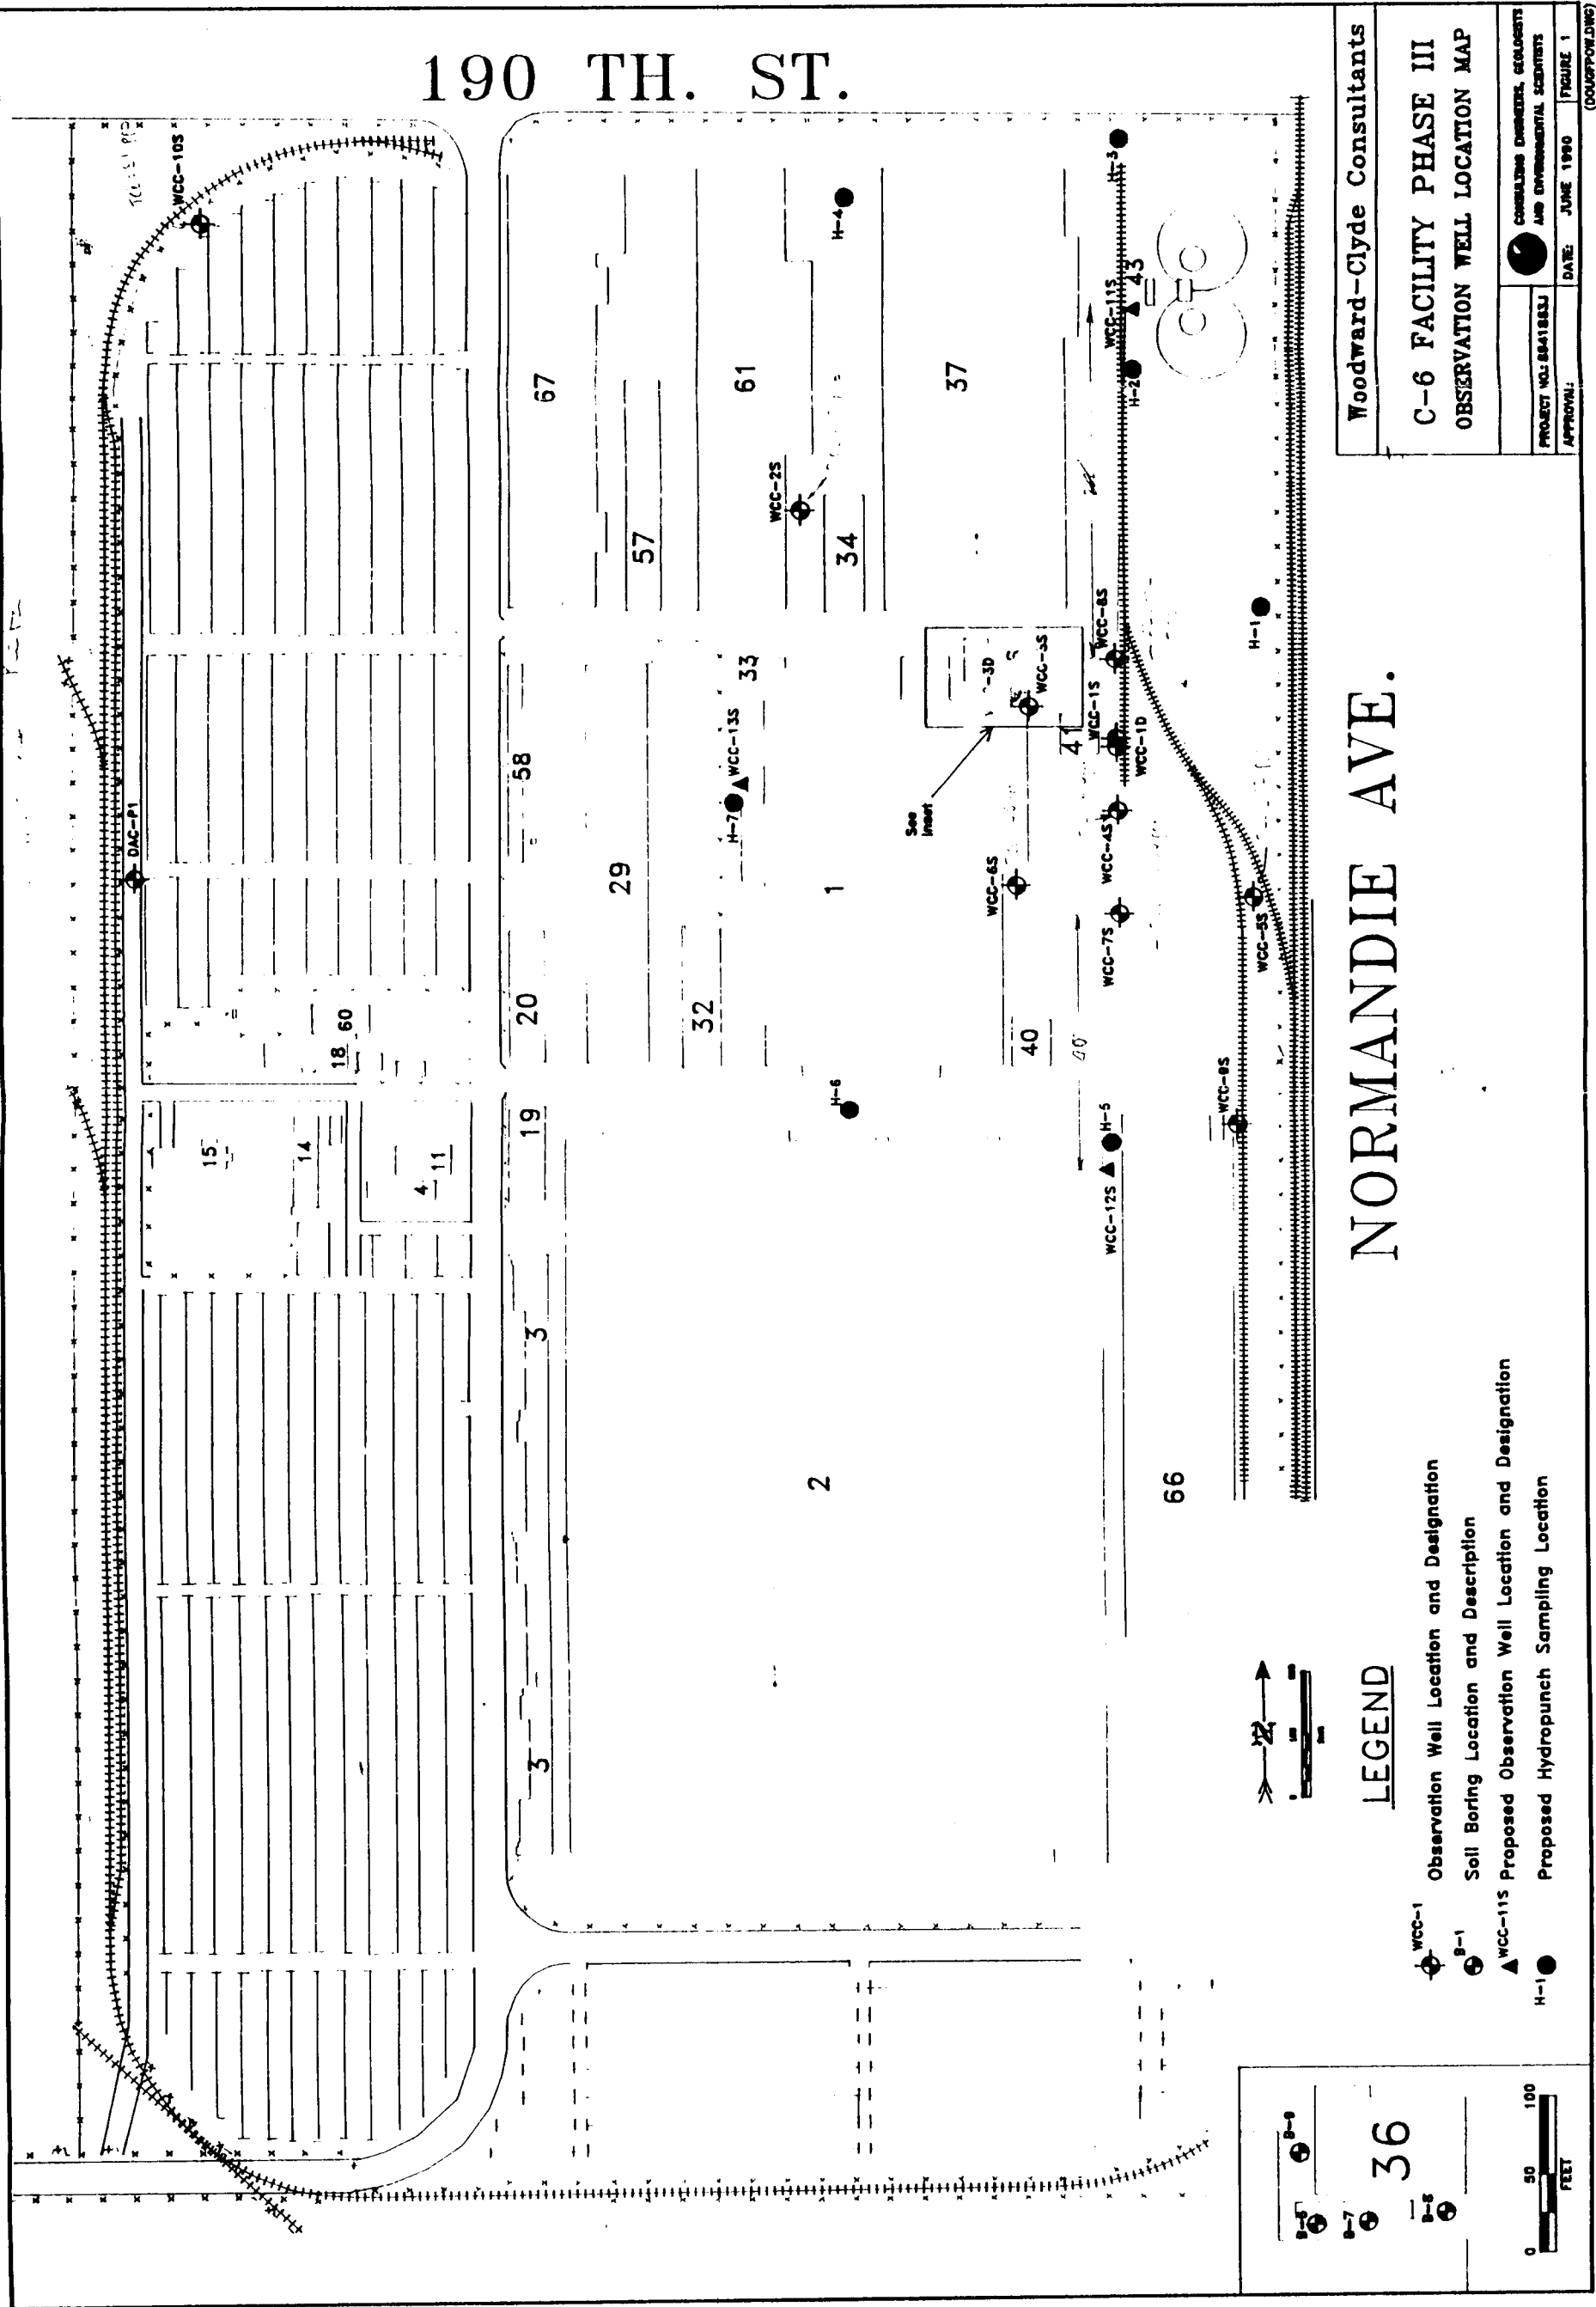
CONSULTING ENGINEER, GEOLOGISTS
AND ENVIRONMENTAL SCIENTISTS
PROJECT NO: 88A183J
APPROVAL: DATE: JUNE 1990 FIGURE 1
(SHEET 1 OF 2)

Woodward-Clyde Consultants
C-6 FACILITY PHASE III
OBSERVATION WELL LOCATION MAP
